June 27, 1997

RE: Petit Lake Dam Site  
Summary of Preliminary Engineering Evaluation

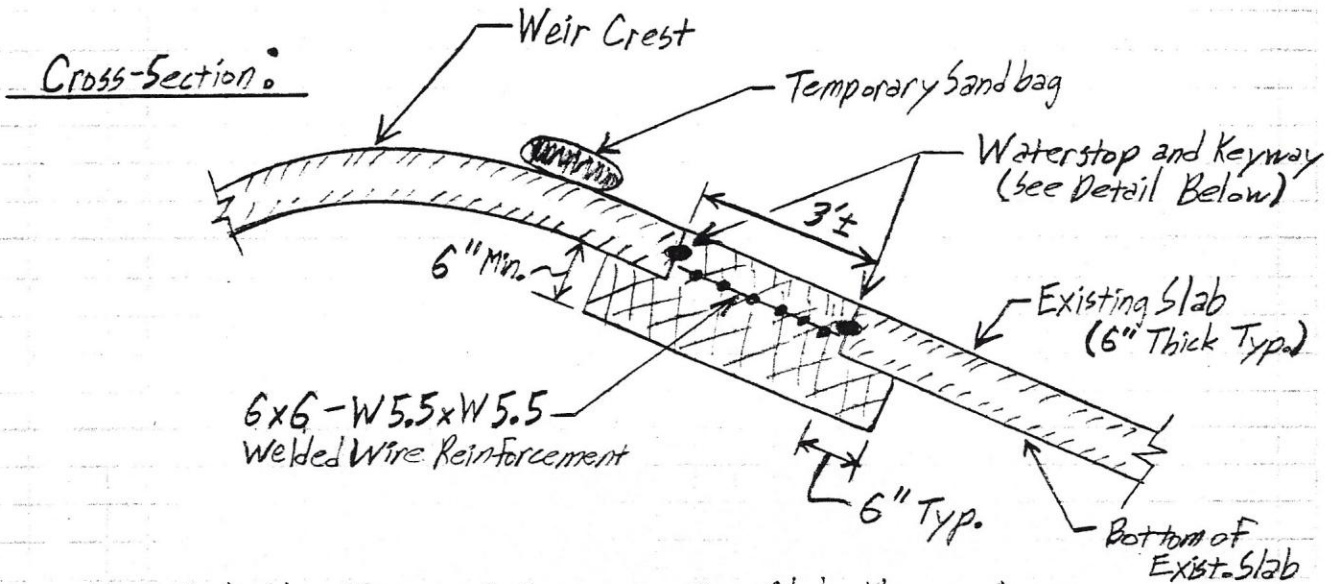
Exhibit A - Spillway Slab Repair Detail

appears to be leaking under the principal control weir and then exiting through the spillway slab on the right side (looking downstream). Upon closer field inspection, this condition does not appear to be caused by water seepage flows beneath the spillway slab. Instead, there is a small steady discharge from the cold water release pipes onto the spillway and flowing over an irregularity in the concrete finish of the slab downstream. This irregular surface of the concrete slab is causing a small hydraulic jump as water flows over it, and this condition may have been misinterpreted by Safe Dams as leakage underneath the spillway. The irregularity should be fixed by using sand bags to temporarily deflect water flows away from the small depression, and then repair slab in accordance with enclosed Detail A to match the relatively smooth uniform finish of the adjacent concrete slab areas.

- Notes:
1. Use 5000 psi Concrete For Slab Repair Area.
  2. Sawcut Existing Slab to remove small depression and about 6" to either side (approx. 3'x3' area).
  3. Use sand bags to reroute water flows away from repair area and keep exposed subgrade in dry condition.

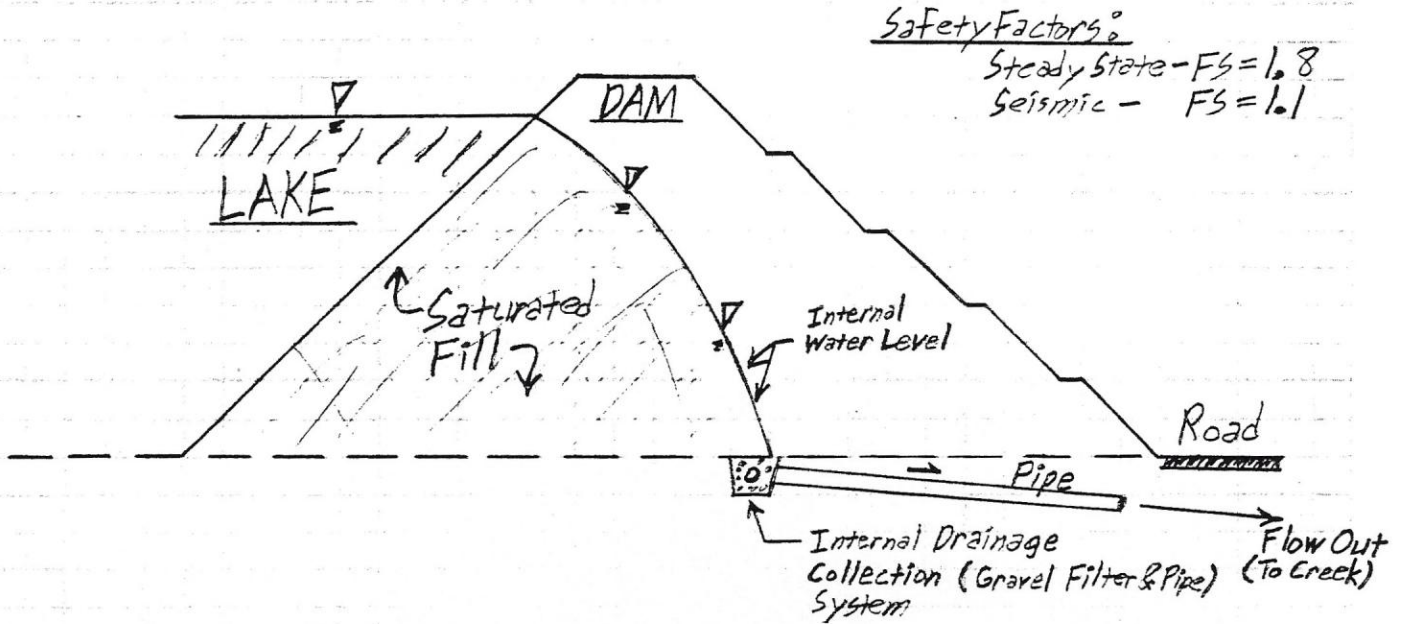
"As Designed" Water Surface (Idealized):

The "as-designed" cross-section geometry was based on the original construction plans showing 6 berms connected by 2.5H:1V slopes, and the resulting minimum safety factors were 1.8 for steady state conditions and 1.1 for seismic event. These two safety factors exceed the Safe Dams' required minimum values of 1.5 and 1.1 respectively for these two design conditions.

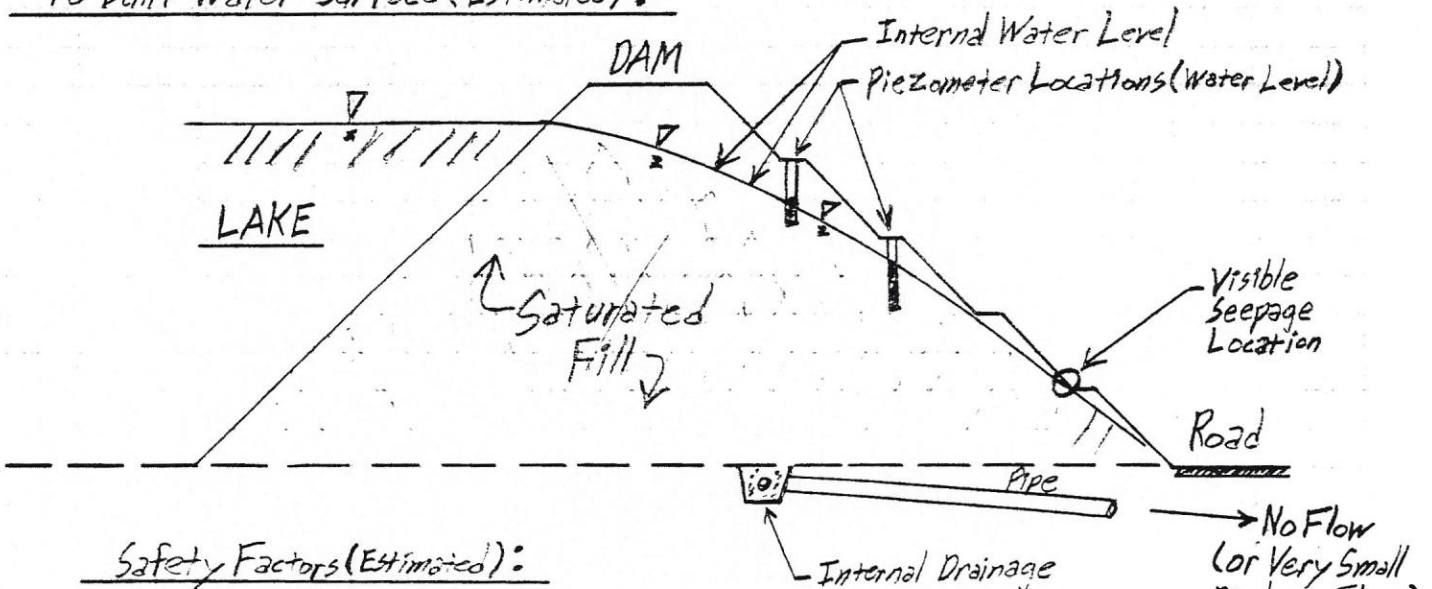
"As Built" Water Surface (Estimated):

Next, the "as-built" embankment geometry was evaluated using the surveyed cross-section from the Corps of Engineers Phase I inspection report (5 berms connected with 2H:1V slopes). This condition also incorporated an assumed phreatic surface interpolated from the piezometer readings and location where seepage has been observed at the surface (see exhibit B for schematic illustration of water level conditions). The resulting calculated minimum safety factors were 1.1 for steady state conditions and 0.7 for the seismic event. These values are well below the Safe Dams' design requirements, and raise some serious concerns about the potential stability of the existing dam structure.

It is important to note that these analyses were relatively simplified and based on several assumptions made due to lack of detailed geotechnical information. However, it is our preliminary opinion that if there is an elevated phreatic surface in the dam, it could cause a potentially dangerous condition within the downstream slope face. Our preliminary evaluation indicates that additional studies are needed as soon as possible to obtain field data to confirm or adjust these assumptions, and then evaluate the dam with data more representative of actual field conditions.

1. JJ&G should prepare 2-3 field surveyed cross-sections of the existing embankment slopes.
2. Additional historical data should be assembled including original design calculations, construction monitoring records, and laboratory testing data.
3. Several water surface observation wells should be installed down the downstream slope face and regularly monitored to determine phreatic levels at various locations and depths.
4. The borings performed for the observation walls will provide the opportunity to obtain undisturbed soil samples and Standard Penetration Tests needed to evaluate existing soil conditions and strength parameters.
